NWEF REPORT 1079

EVALUATION OF A-7E AIRCRAFT THERMAL RADIATION CLOSURE FOR LIGHT LEAKAGE

NAVAL WEAPONS EVALUATION FACILITY
ALBUQUERQUE, NEW MEXICO 87117

20 April 1971

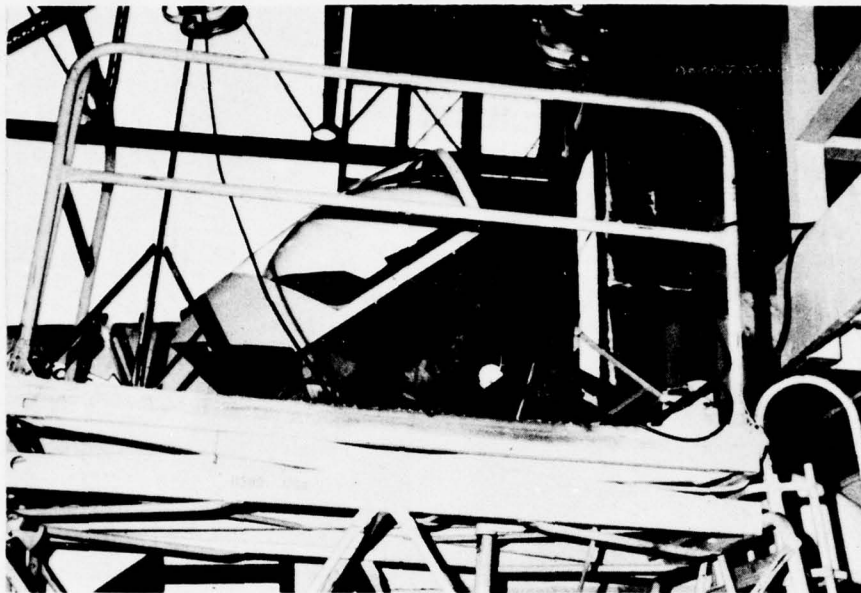
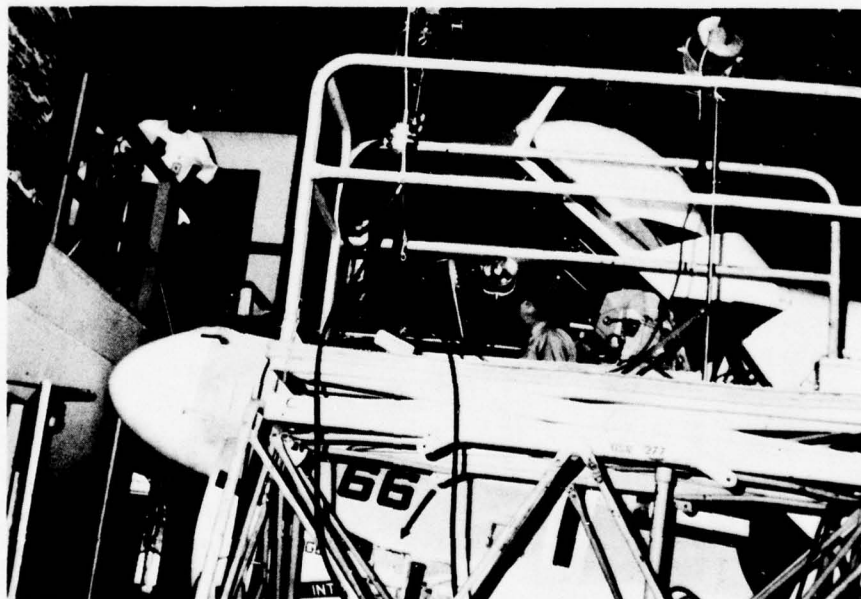
FIGURE 1. LAMP POSITIONING, PHASE I TESTS

Phase I tests were conducted on 23 March 1971 in the NWEF hangar to identify light leaks existent prior to retrofit. Four 1,000-watt quartz-iodide photo floodlamps, two on each side of the aircraft, were positioned on maintenance stands as shown in Fig. 1. Lamps were positioned so that a uniform ambient light intensity of approximately 3,000 footcandles was measured in the cockpit.

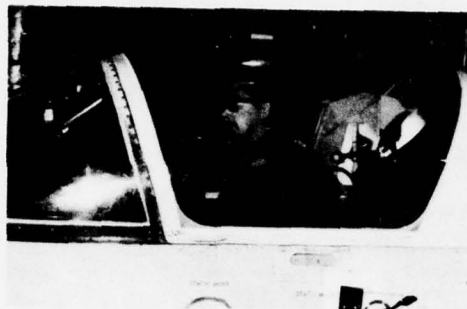
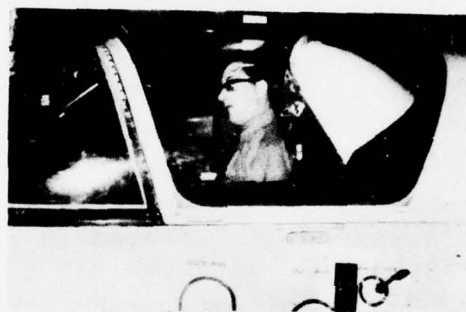
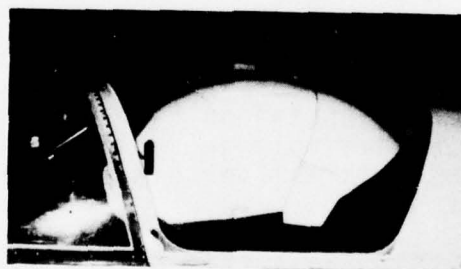
FIGURE 3. THERMAL RADIATION CLOSURE POSITIONS

Ambient internal light levels were not measured during Phase I tests. Nor was any attempt made to measure the magnitude of leaks observed. Seal areas along the interfaces of the movable segments revealed no unacceptable leakage except as previously noted. Following visual observations, the TRC was pneumatically cycled ten times from the READY position (Fig. 3). No significant changes in leakage characteristics were noted.
